# DockSafe

## Electric Shock Drowning: The Hidden Crisis in America's Freshwater Marinas

*Prevalence, Liability, Regulation, and the Physics of a Preventable Death*

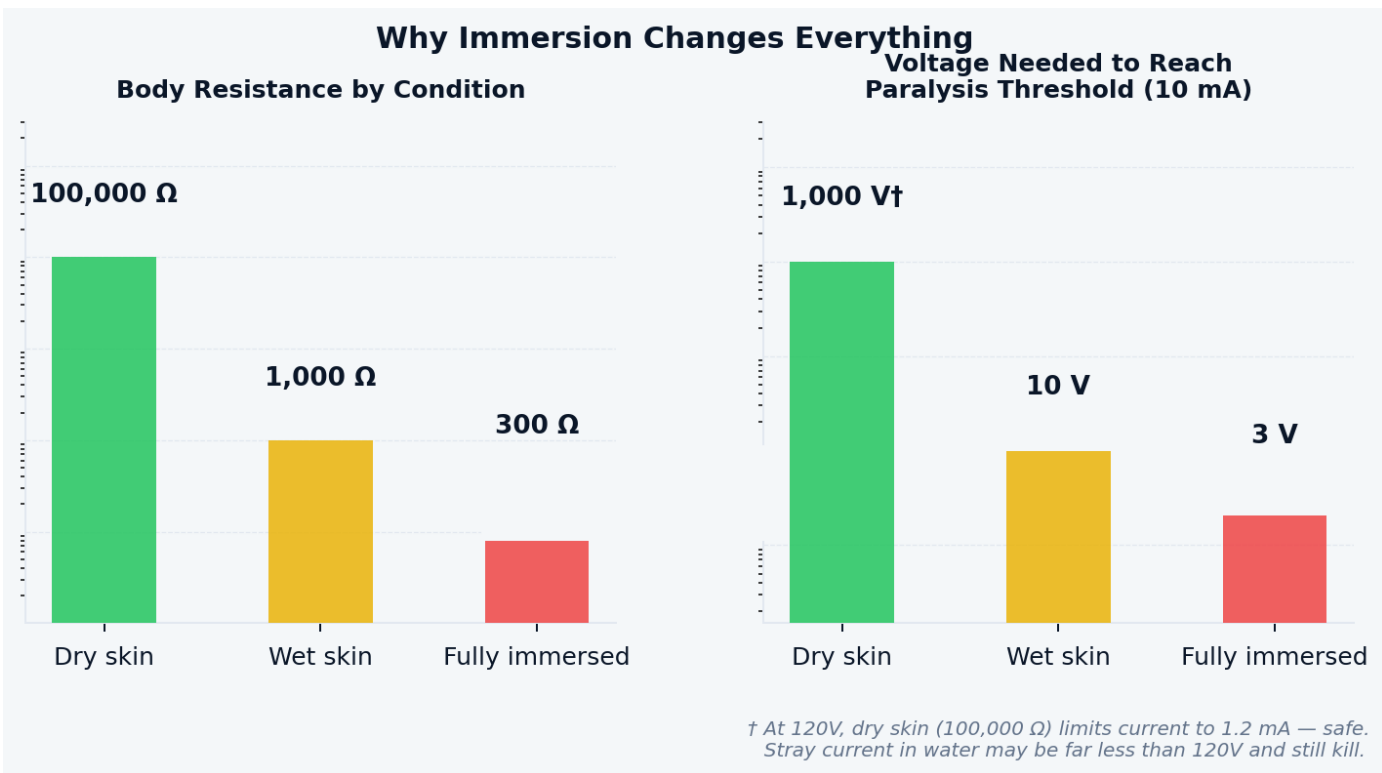
Figure 2. Left: body resistance drops dramatically from dry skin to full immersion. Right: the voltage required to drive a paralysis-level current at each condition — calculated directly from Ohm's Law ( $V = I \times R$ ).

Immersion collapses that resistance to roughly 300 ohms. The math changes completely. The source voltage doesn't need to be 120V anymore — it doesn't even need to be close. At 300 ohms of body resistance, **3 volts is all it takes to drive 10 milliamps through a swimmer** ( $3 \div 300 = 0.010$  amps). That is the paralysis threshold. Three volts. The kind of gradient that can exist in the water near a marina with multiple leaking boats — none of which have triggered any alarm.

<b>10 milliamps</b>	Sufficient to cause muscular paralysis preventing swimming — one-fiftieth the current of a 60-watt light bulb.
<b>~300 ohms</b>	Immersed body resistance, versus 100,000 ohms for dry skin. Immersion reduces resistance 300x.
<b>3 volts</b>	Voltage required to drive 10 mA through an immersed body (Ohm's Law: $0.010A \times 300\Omega = 3V$ exactly). In-water body resistance varies 200–500 $\Omega$ by individual, so the real-world range is roughly 2–5V — all well below any household source.
<b>2 volts/foot</b>	Electric field danger threshold established by NFPA field research.
<b>30 mA</b>	NFPA threshold established as sufficient to precipitate ESD (Fire Protection Research Foundation, 2017).
<b>Unknown radius</b>	The danger zone cannot be predicted without direct measurement. Field research documents incapacitation at 20+ feet; in lower-conductivity water the radius extends further. No safe assumed distance.

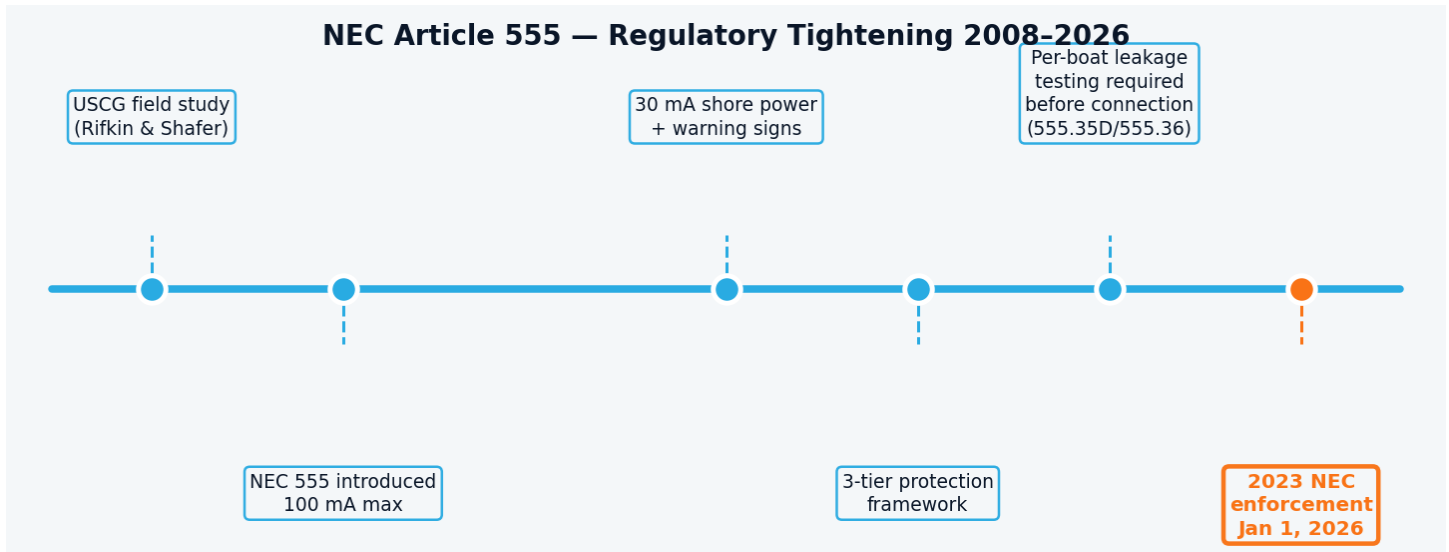
Figure 5. NEC Article 555 evolution from foundational field research in 2008 to the 2023 per-boat leakage testing requirement, effective January 1, 2026.

The National Electrical Code has progressively tightened marina electrical requirements since 2011. Each revision has moved toward more sensitive circuit-level protection, reflecting a recognition that the earlier 100 mA threshold was wholly insufficient. The 2023 edition adds two significant requirements taking effect January 1, 2026: Section 555.35(D) requires that any marina with four or more shore power receptacles must have a listed leakage current measurement device available and must use it to test each boat's leakage before allowing it to connect. Section 555.36 goes further — vessels that fail

<b>2011 NEC</b>	First introduced ground-fault protection at marinas — 100 mA maximum on main overcurrent devices.
<b>2017 NEC</b>	Reduced to 30 mA for shore power receptacles. Added mandatory warning signage.
<b>2020 NEC</b>	Three-tier framework: 30 mA shore power, GFCI (4–6 mA) standard receptacles, 100 mA feeders.
<b>2023 NEC</b>	Requires a listed leakage measurement device be available and used to test each boat before connection (555.35D). Vessels failing the test may be denied shore power (555.36). Still circuit-level and per-boat only — not water column measurement. Effective January 1, 2026.
